7<sup>th</sup> Cooperation Forum under the  
Cooperative Mechanism on the Safety  
Of Navigation and Environmental Protection  
In the Straits of Malacca and Singapore  
Agenda Item : 2.1 (i)

CF7/2  
1 September 2014

# Project MYWREMS (MalaYsian WREckManagement System)

By: Malaysia Marine Department

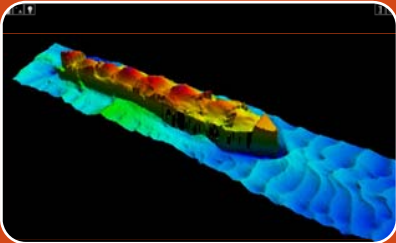
## MV CALIFORNIA

- OFF PULAU UNDAN, 01° 57.79' N, 102° 10.54' E
- Wreckage is stable, Cut partially to maintain water depth at 32m CD a for safe under keel clearance. Current least depth 32 meter

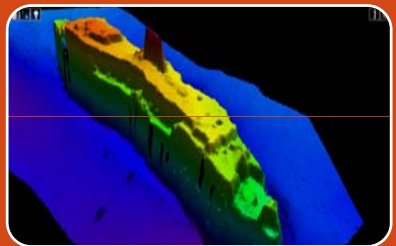
## MV ROYAL PACIFIC

- 15.4 NM WEST OF TANJUNG TUAN, 02° 27.206' N, 101° 36.149' E
- Wreckage is stable and marked by Isolated Danger Buoy Fl(2) 10sec
- Current least depth 42 meter

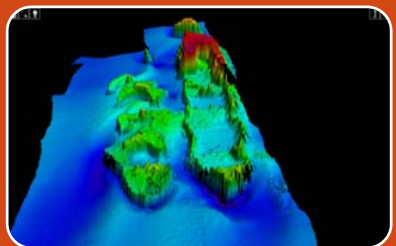
## MV ICL VICRAMAN

- 5.5 NM SOUTHERN OF TANJUNG TUAN, 02° 18.495' N, 101° 51.160' E
- Wreckage is stable , 23m ACD and charted. Current least depth 24

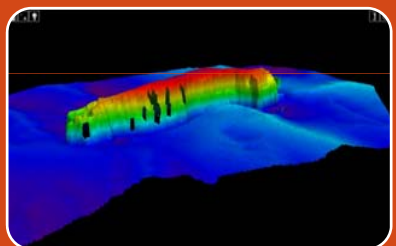
## MT SINGAPURA TIMUR

- 5NM OF PULAU UNDAN, 01° 58.171' N, 102° 14.132' E
- Wreckage is stable, Least depth 30m above the wreck and charted.
- Current least depth 34 meter

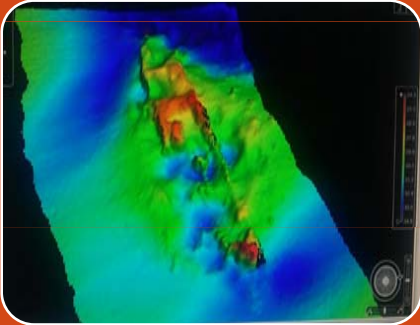
## Unknown Wreck

- OFF MUKA HEAD, 05° 09.83' N, 100° 09.28' E
- Least depth 23 meter

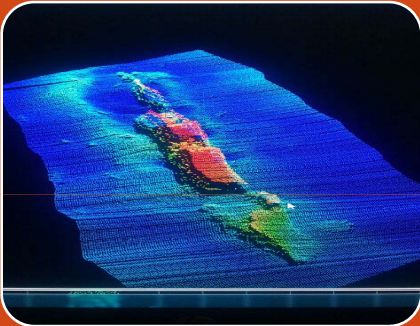
## Unknown Wreck

- OFF PULAU KENDI, 05° 28.34' N, 099° 54.58' E
- Least depth 31 meter

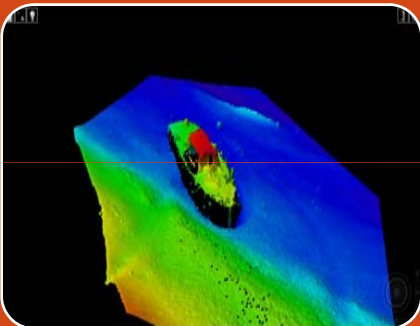
## Unknown Wreck

- LUMUT, 04° 16.14' N, 100° 39.88' E
- Least depth 6 meter

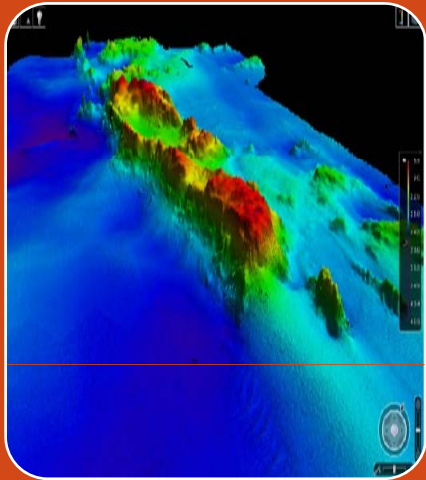
### Unknown underwater obstruction

- K. LINGGI, 02° 26.16' N, 101° 57.23' E
- Least depth 6.7 meter
- Marked by Isolated Danger Buoy Fl(2) 10sec

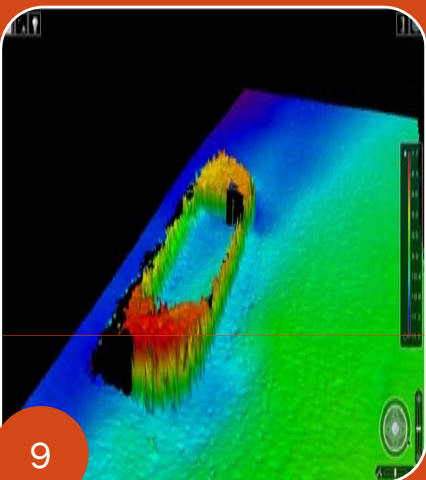
### Unknown Wreck

- LUMUT, 04° 14.31' N, 100° 38.26' E
- Least depth 7 meter
