**DIRECTORATE GENERAL OF SEA TRANSPORTATION
MINISTRY OF TRANSPORTATION
REPUBLIC OF INDONESIA**

**AWARENESS ON HIGH RISK SITUATION OF BATU
BERHANTI LIGHT BUOY IN SINGAPORE STRAIT
(*assure sustainable isolated danger marking*)**

**40TH TRIPARTITE TECHNICAL EXPERT GROUP (TTEG) MEETING
SINGAPORE
7-8 OCTOBER 2015**

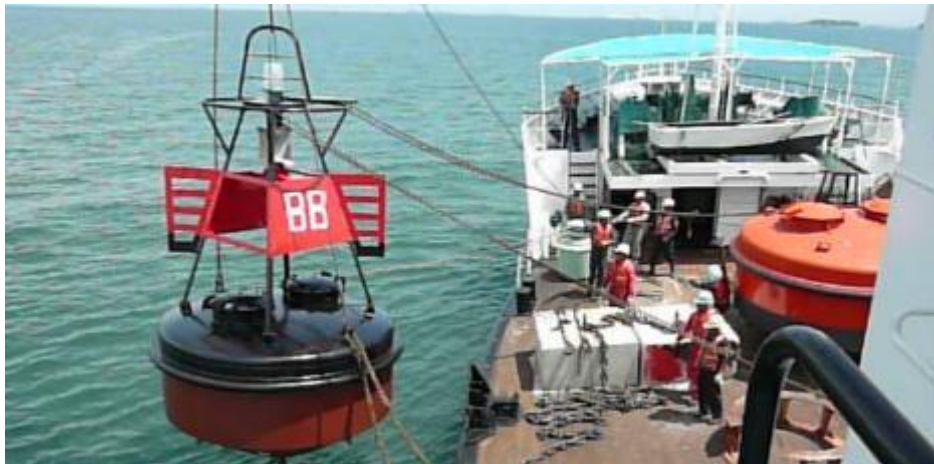
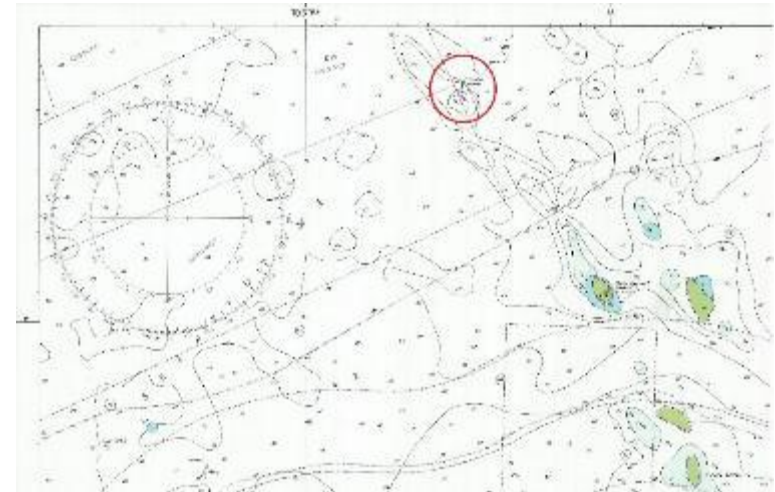
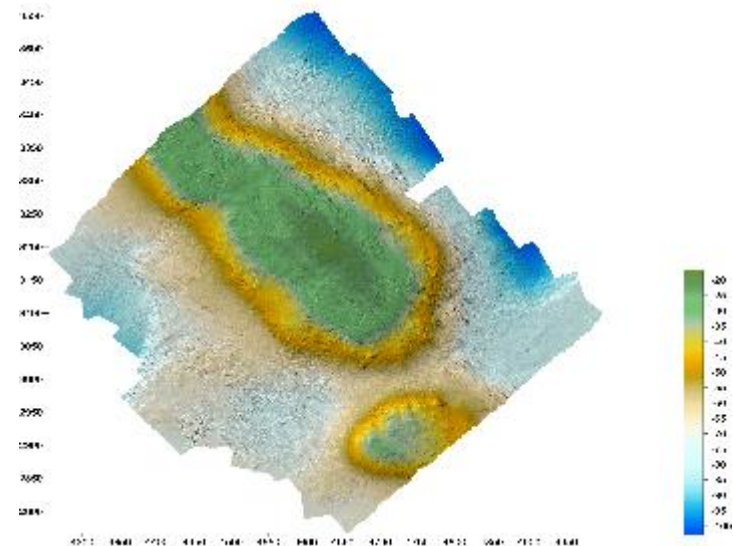
OVERVIEW OF BATU BERHANTI (2)

- ❑ The role of the Batu Berhanti light buoy is highly essential to the safety of navigation and marine environmental protection in Singapore strait.
- ❑ The Batu Berhanti light buoy is a steel-made swift current light buoy which is anchored using 8 ton of couple ballast on a tiny flat surface of rock about 20 meters below mean sea level.

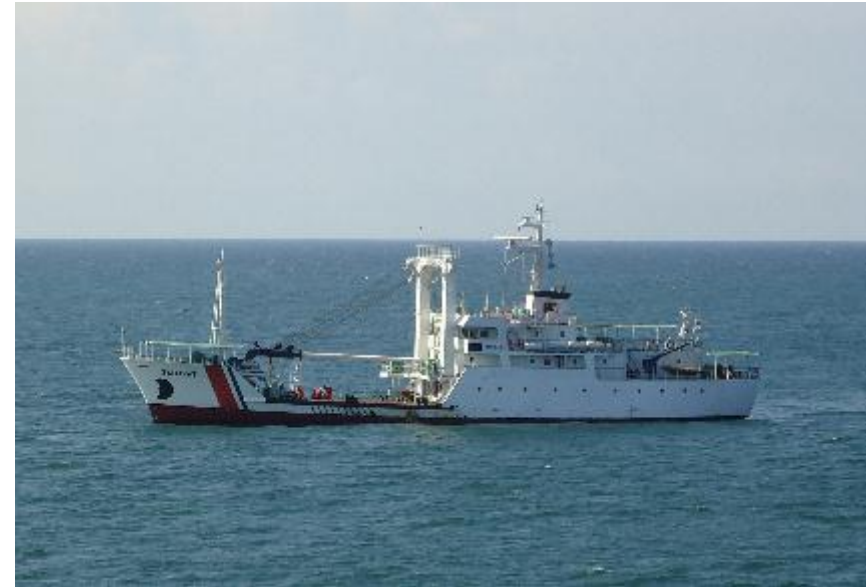
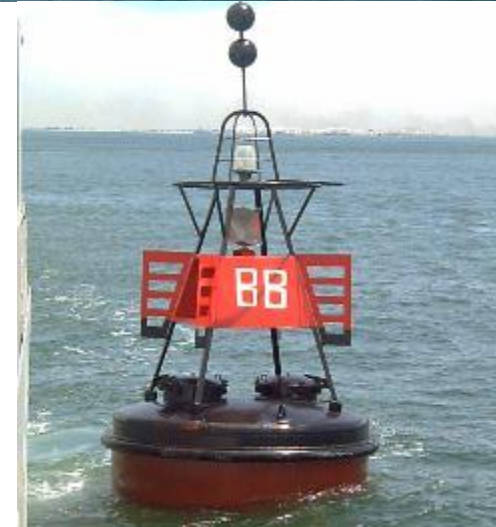
EFFORTS OF DGST TO MAINTAIN BATU BERHANTI LIGHT BUOY (2)

- ❑ In case of incident that cause the buoy off-station, Indonesia through the District of Navigation of Tanjung Pinang immediately dispatches buoy tender vessel along with the competence technicians and crews to lay new light buoy in position and to ensure it work properly.
- ❑ The MPA Singapore actively assist to monitor the status of the buoy and give immediate information to Indonesia on any anomaly occurs to the buoy in particular when a drifted buoy that was suffered a hit by vessel has been found by the MPA at their area.

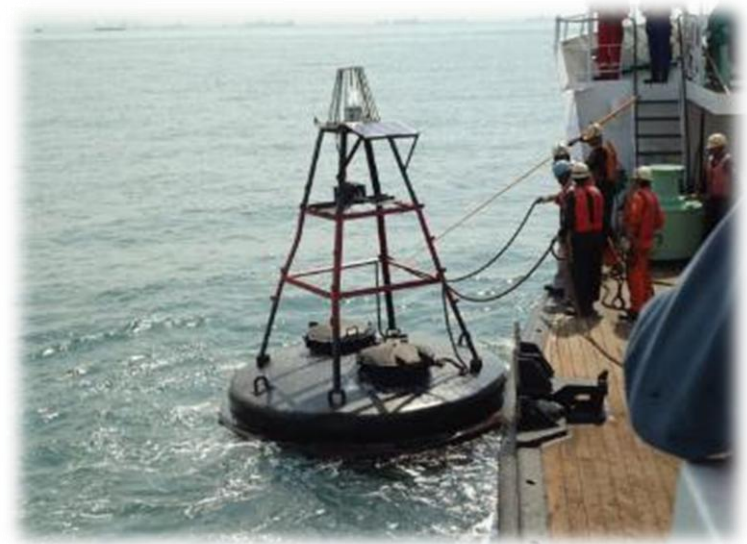
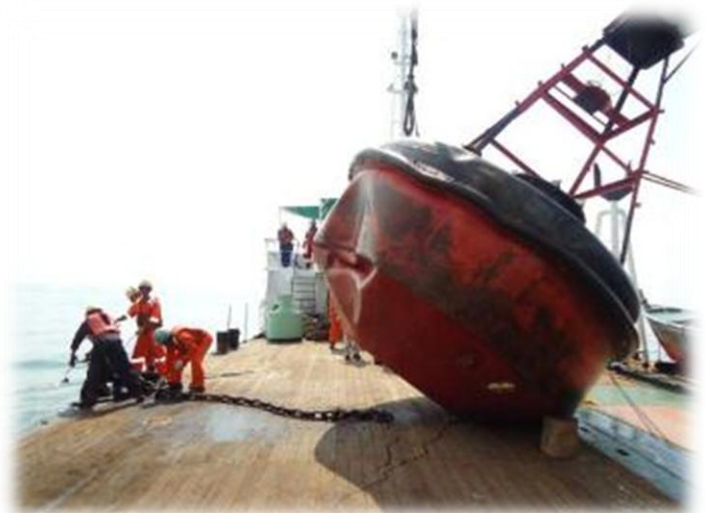
SITUATION AND RISK

- ❑ Batu Berhanti Light Buoys remain as the most AtoN suffered of hits by vessel and drifted away. According to our record, during the period of January to August 2015 there were 5 (five) incident to the buoy which were entirely hit by unidentified transiting vessels and ran without reporting. Batu Berhanti Light Buoy is located at Singapore Strait, and it's under the operation area of District Navigation of Tg. Pinang, Directorate General of Sea Transportation.
- ❑ This situation seriously threat the safety of navigation in Singapore strait TSS. However, considering in efficiency of such measures and potential danger due to the time gap between the incident and the reinstallation of the buoy, solution on this situation should be worked out

- ANF Committee is requested to allow budget for installation of AIS AtoN on Batu Berhanti Light Buoy to enable alerting at the concerned VTS stations on potential collision of vessel to the buoy and to identify the colliding vessel.

- Indonesia will install Surveillance CCTV at Batu Berhanti Light Beacon (1 Nm South East of Batu Berhanti Light Buoy) to enable recording of evidence on the collision to the buoy.

- Permit direct communication from Batam VTS to the ship potentially hit the buoy within the concerned reporting sector to allow early notification to the master on potential harm of the ship's movement to the buoy.

- The meeting is requested to decide claim mechanism on the damage to the buoy or missing buoy made by DGST to the concerned flag state with CC to ANF Secretariat. The concerned flag state is further requested to encourage the ship owner to pay compensation to ANF Account. Such claim should includes damage suffered by other vessels and marine pollution the occurred due to the absence of the buoy.

- Further, TTEG should considere to evaluate routing system on the concerned TSS segment to provide more secure navigable route, to explore possible technology to secure the buoy such as application of dynamic position to buoy or other possible scientific solution, and to equip the buoy with Ocean Data Sensor.
